Evaluating Composition Shingles

Is my roof damaged by hail?

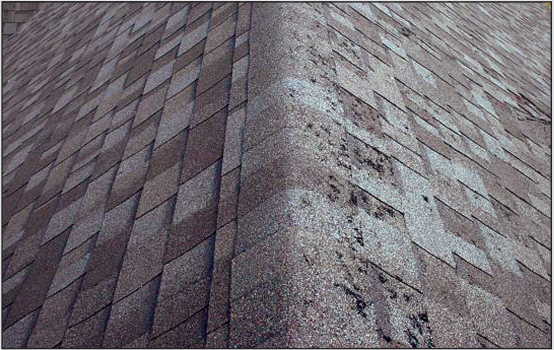
Directionality of Hail

During a hail storm, depending on the direction and velocity of the wind, some slopes may be more susceptible to hail damage while other slopes may have minimal or no damage.

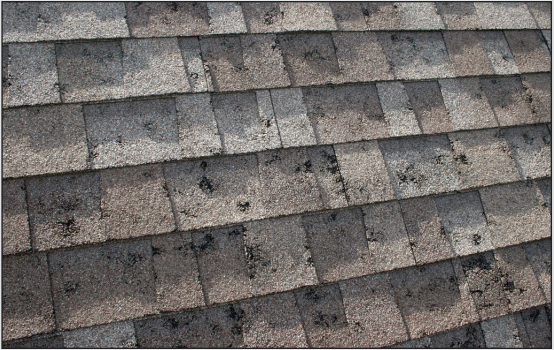
Hail – The number, size and hardness of the hailstones can vary tremendously within a small locality. Velocity and direction of the wind are also factors.

State Farm® evaluates each roof individually. The number, size and hardness of the hailstones can vary tremendously within a small locality. Velocity and direction of the wind are also factors. Other factors are roof pitch, age and condition.

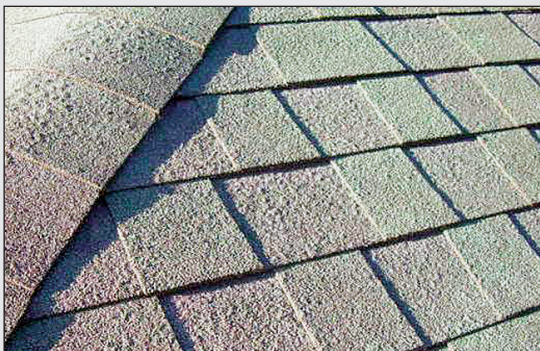
Bruise – Created when a hailstone crushes the mat material and can displace granules. Bruises may cause premature deterioration and weathering, eventually resulting in a hole in the shingle.

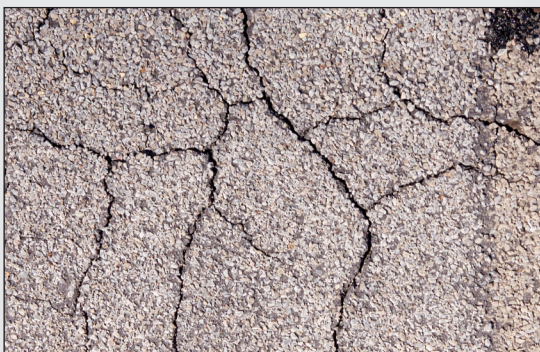
Closed and Popped Blisters

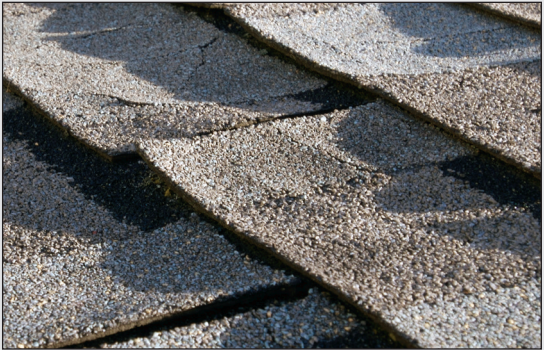
Cracking – Web-like pattern of cracks in surface of shingles due to natural weathering.

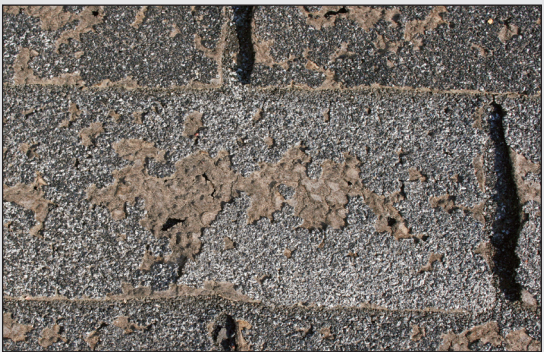
Curling/Cupping – This is the result of normal weathering of the asphalt shingle.

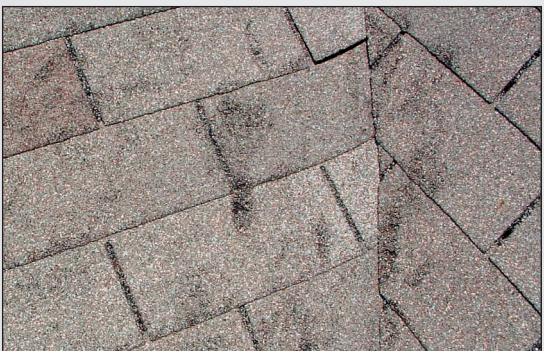
Flaking – As the natural weathering of shingles continues, small chunks of the granule coating begin to delaminate from the mat.

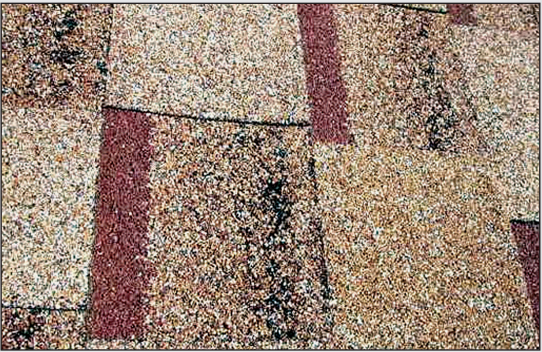
Footfall – Potential loss of granules caused by walking on a roof.

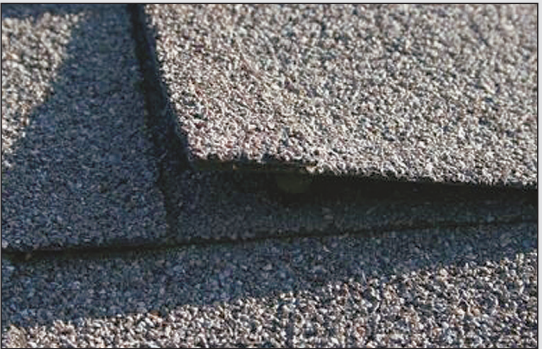
Manufacturing Defects – This may occur during the manufacturing of shingles.

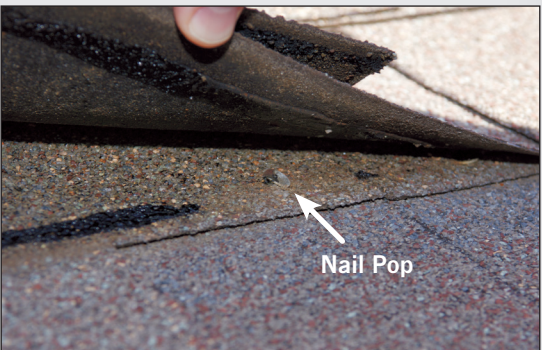
Nail Pop – An elevated nail that can push a portion of the shingle off the roof plane. Over time, this pop can cause a hole in the shingle.
